UST TALK

A Newsletter for Underground Storage Tank Owners / Operators

Spill Buckets – the Weak Link in the UST Chain

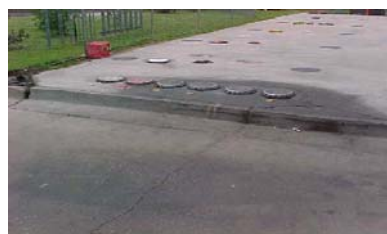
Note the extensive staining surrounding the fill ports at the Mississippi truck stop. Clearly, the delivery drivers were not being as careful to avoid spills as they should have been. Photo courtesy of the Mississippi Department of Environmental Quality

Thus far, more than 4,800 gallons of diesel fuel have been removed from the groundwater. It's possible that even more petroleum product is bound up in the soil. Remember – the tanks and piping at this truck stop did not leak. This release appears to

have been caused entirely by spills during delivery, and by spill buckets that did not contain the product.
